INDUSTRIAL EQUIPMENT SURVIVAL/RECOVERY FEASIBILITY PROGRAM DURING EVENT DICE THROW

The Boeing Company
P.O. Box 3707
Seattle, Washington 98124

31 December 1976

Final Report

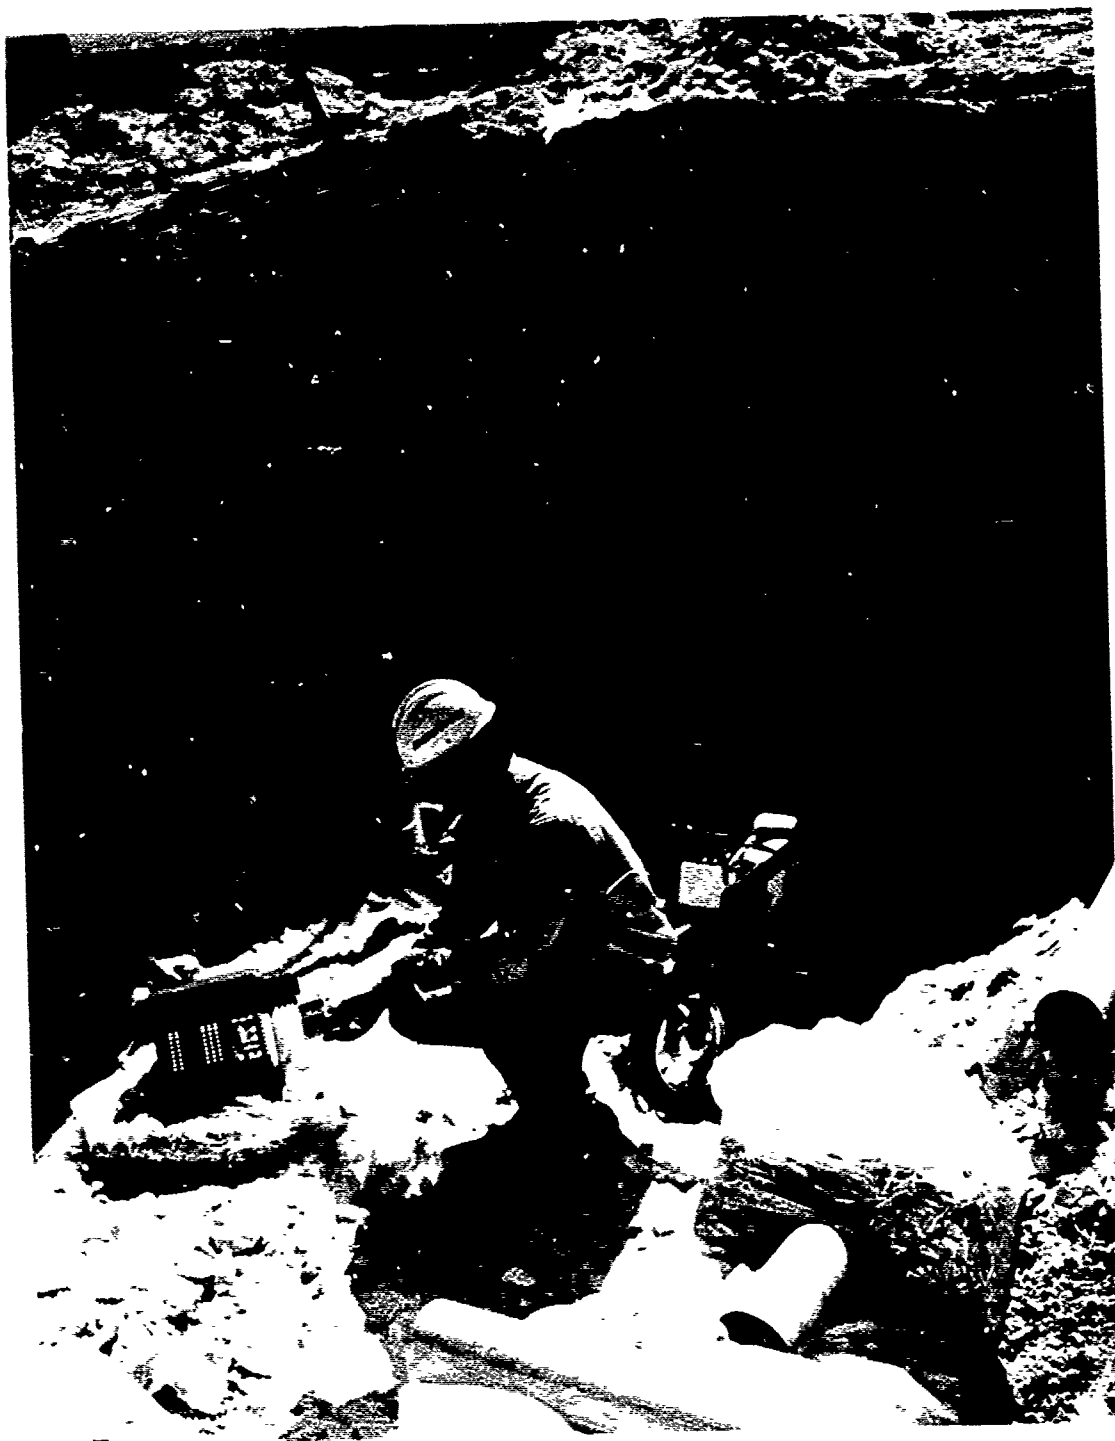
FIGURE 9: DESK AND HAND CALCULATORS, MINIBIKE AND PIPES
TO BE EMPLACED AT 600 PSI

The major equipment item placed at 600 psi was a small minibike to represent transportation equipment. The minibike possessed pneumatic tires, shock absorbers, transmission, engine, gasoline tank, brakes, frame and padded seat. Thus, most of the items common to transportation equipment except windows, enclosed cab, and batteries were represented. Other equipment items included three mechanical/electrical calculators and three electronic hand calculators. One pocket watch and hollow plastic cubes containing several dice and an hour glass were also placed. The idea behind this was that if the plastic cubes survived, any changes in the dice faces would give an indication of the

The tests showed that a combination of crushable material and earth arching can protect quite soft machines against very high overpressures (up to 600 psi). A minibike survived* at 600 psi (see Figures 9 and 10) and full scale industrial machines survived at 200, 80 and 40 psi (see Figures 11 and 12 for example). Numerous smaller machines also survived at all these overpressures. Since a spectrum of damage was desired some items such as the calculators in Figure 13 were purposely buried with insufficient arching. The three desk calculators buried at 600 psi showed progressively less damage with increasing depth. The arch failed as expected at the shallowest depth (Figure 14) and everything at this level was damaged. Interestingly the hand calculator and the very soft "Got-A-Minute" game survived at the middle level even though the desk calculator was damaged. Judging from crush gauge readings (see Gauge section below) the repairable damage to the lowest desk calculator was caused by ground shock rather than arch failure.
